# The CDF II Silicon Detector Longevity and Performance

**Michelle Stancari**  
Fermi National Accelerator Laboratory  
(on behalf of the CDF Silicon group)

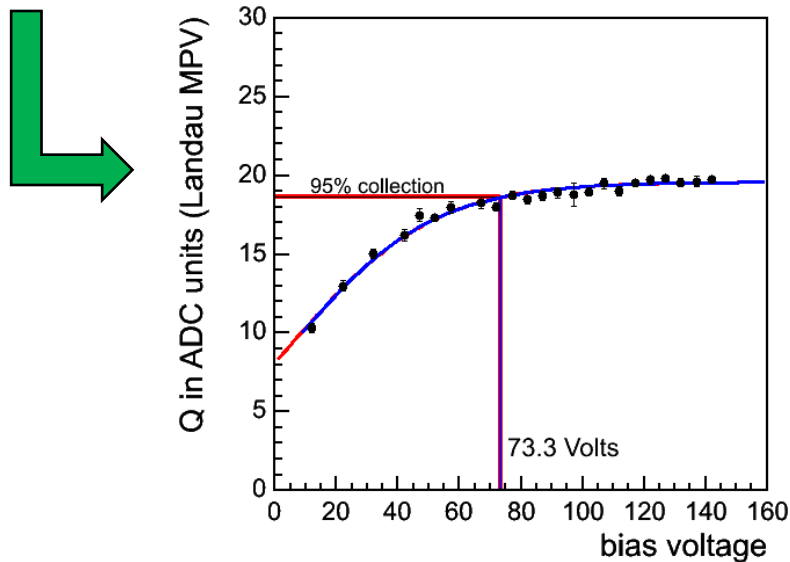
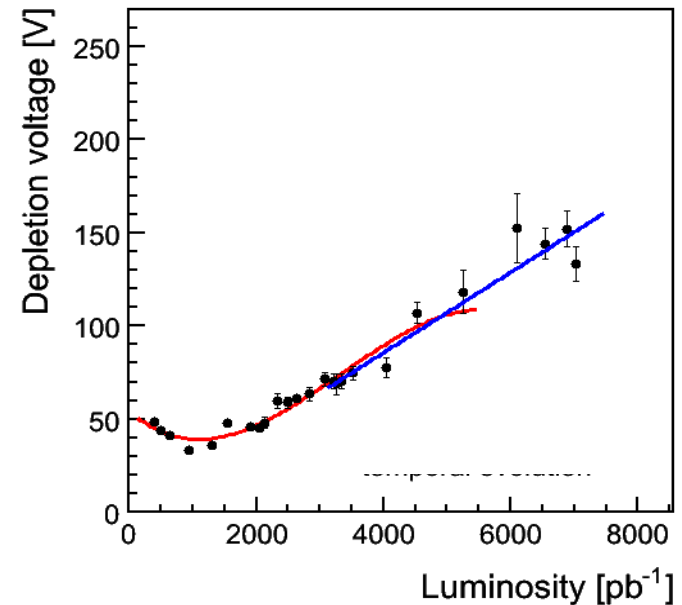
# Depletion Voltage Measurements

- ▶ Measure collected charge for different bias voltages
- ▶ CDF defines depletion voltage,  $V_d$ , as the minimum voltage that collects 95% of the charge at the plateau

- ▶ Depletion Voltage as a function of integrated luminosity  
3<sup>rd</sup> order polynomial fit around the inversion point  
Linear fit to extrapolate to the future

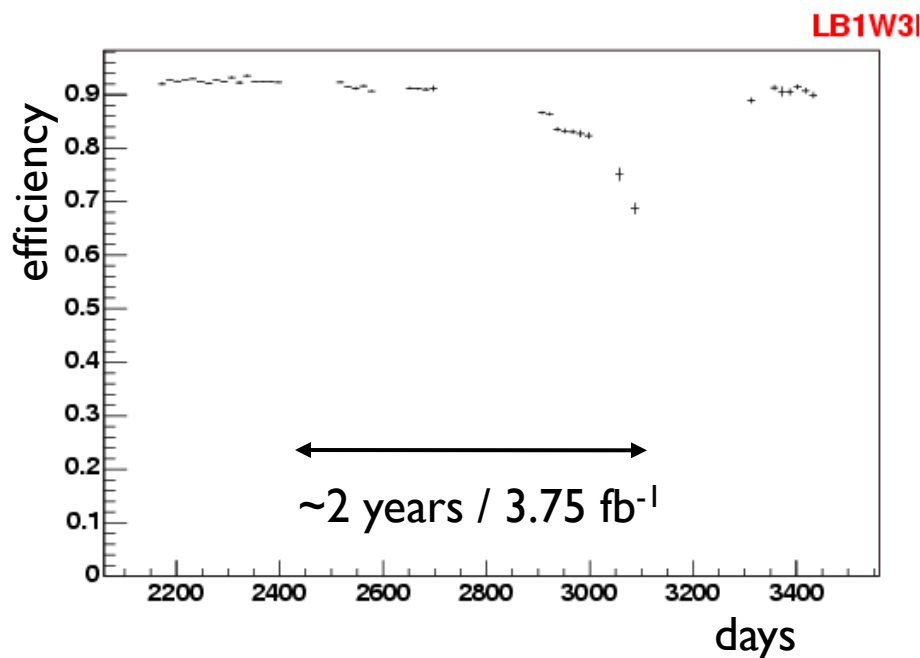
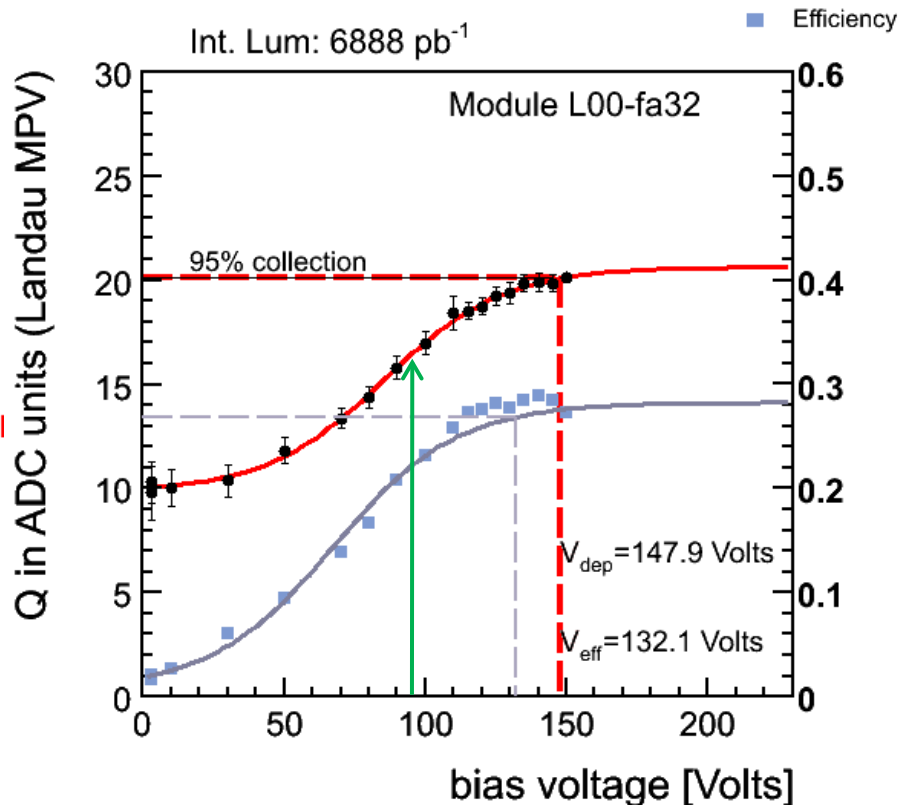
# L00 depletion voltage measurement

Underdepletion is **not** instant death, but a slow process of decreasing efficiency!

A single L00 ladder was unintentionally underdepleted in 2007-08. Its efficiency was restored after a bias voltage increase from 95 to 150V.

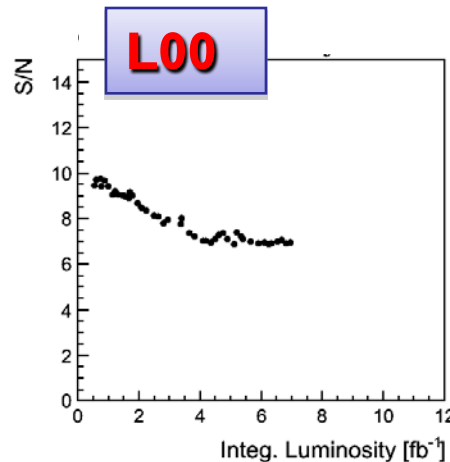
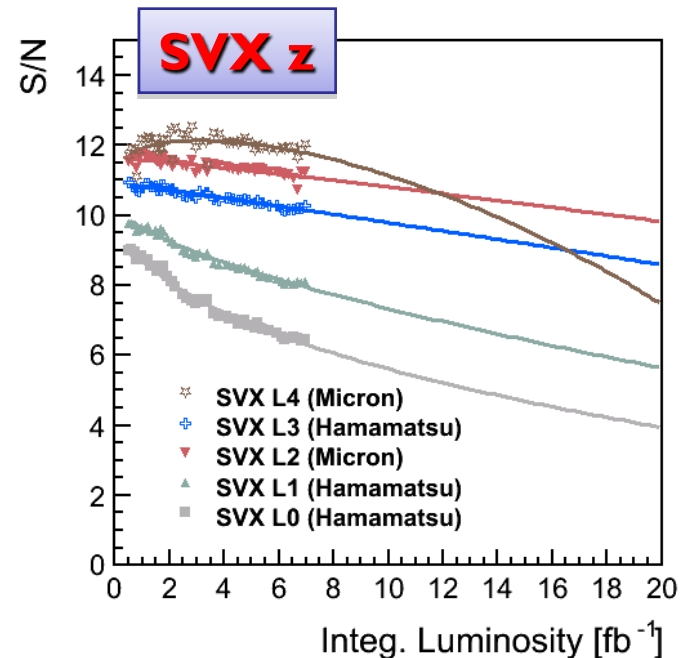
# Signal/Noise Measurements

- ▶ Signal from  $J/\psi \rightarrow \mu^+ \mu^-$  tracks strip cluster charge
- ▶ Noise estimation from regular calibrations
- ▶ Extrapolations assume fully depleted sensors
- ▶ Studies in progress to understand the effect of decrease S/N on physics analyses for run 3 (see recent CDF talk to PAC)

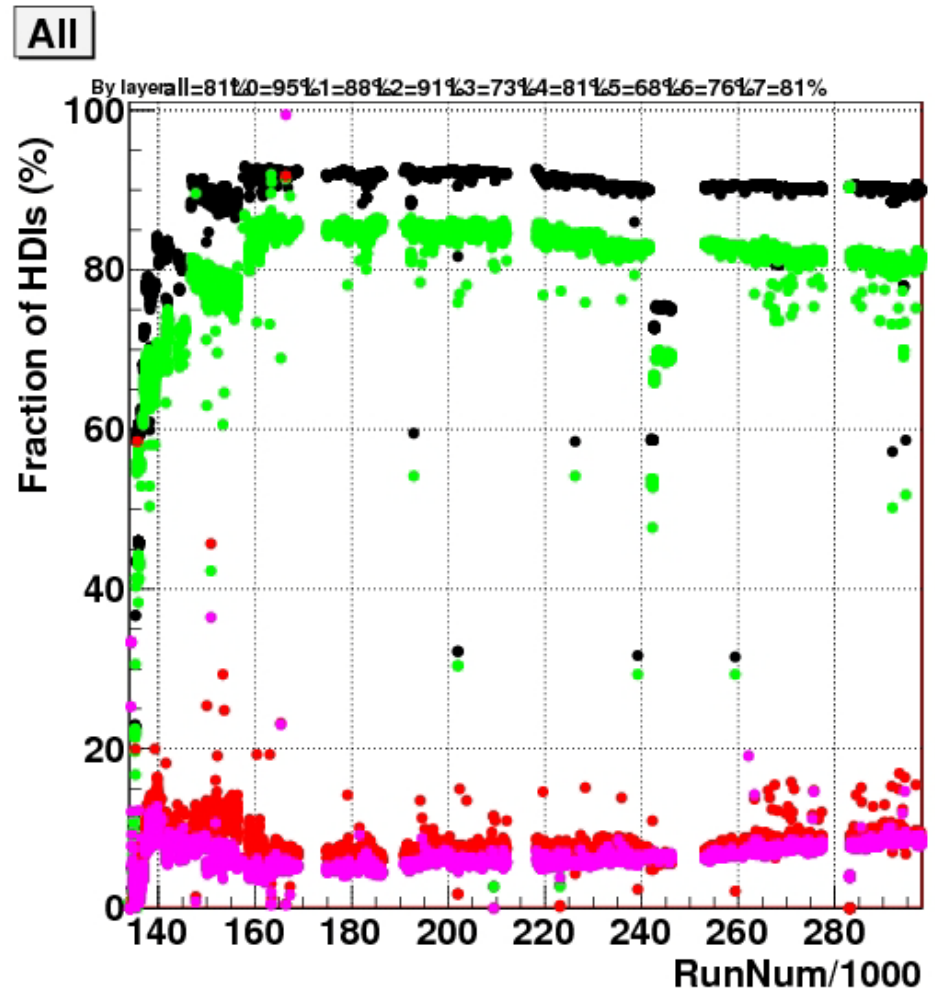
# Ladder Failures and Challenges

One ladder = chain of 4-14 readout chips (128 microstrips each chip)

Currently ~90% ladders integrated, ~80% good (< 1% error rate), ~10% bad with an average error rate of 10%

Great performance after 9 years of running

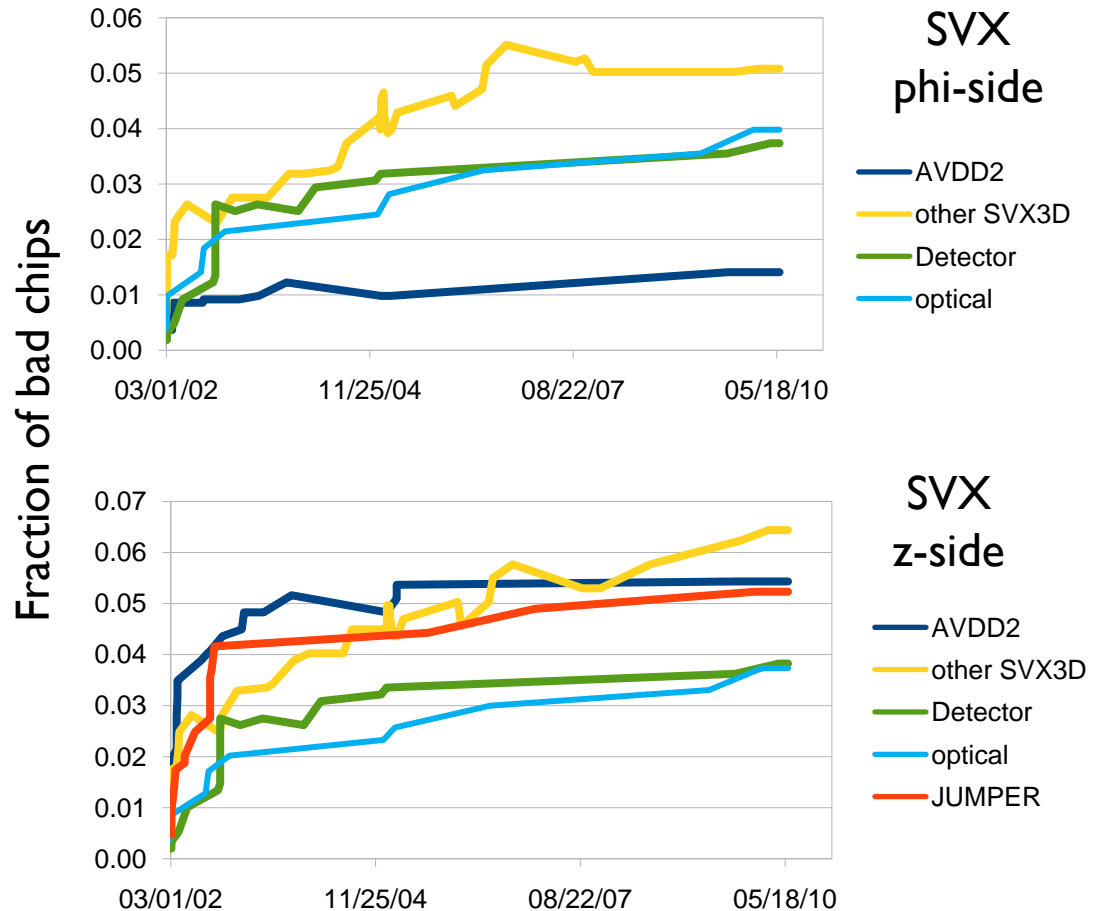
# Chip Accounting - SVX

**Detector** includes port cards, junction cards, cables, and the sensors themselves.

**Optical** is bit errors from the internal DOIM data transmitters

**Jumper** is SVX3D chip failures due to wire bond resonances

**AVDD2** is a SVX3D chip failure mode caused by thermal cycles

**Other SVX3D** includes all other chip failure modes

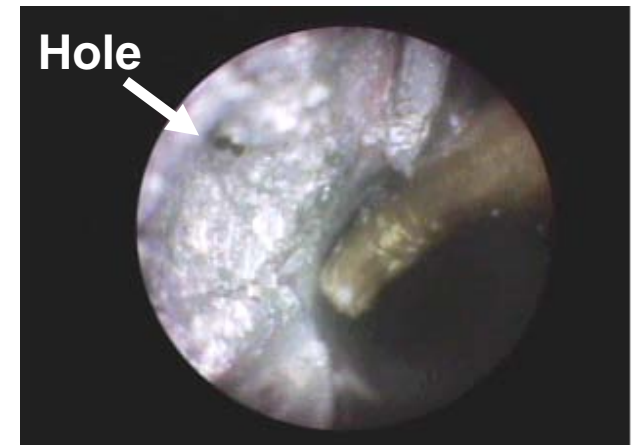
# ISL Cooling System: The Saga of 2007

- ◆ In 2007, bad vacuum in ISL indicates presence of leaks. Eventually, east side bad enough to interfere with detector operations.
- ◆ Found high acidity in coolant, **pH = 2**
- ◆ Formic acid had formed out of the glycol/water mixture (after warming up during the 2006 shutdown)
- ◆ Corrosion affected vulnerable parts (Al-alloys welding, brass e-valves)

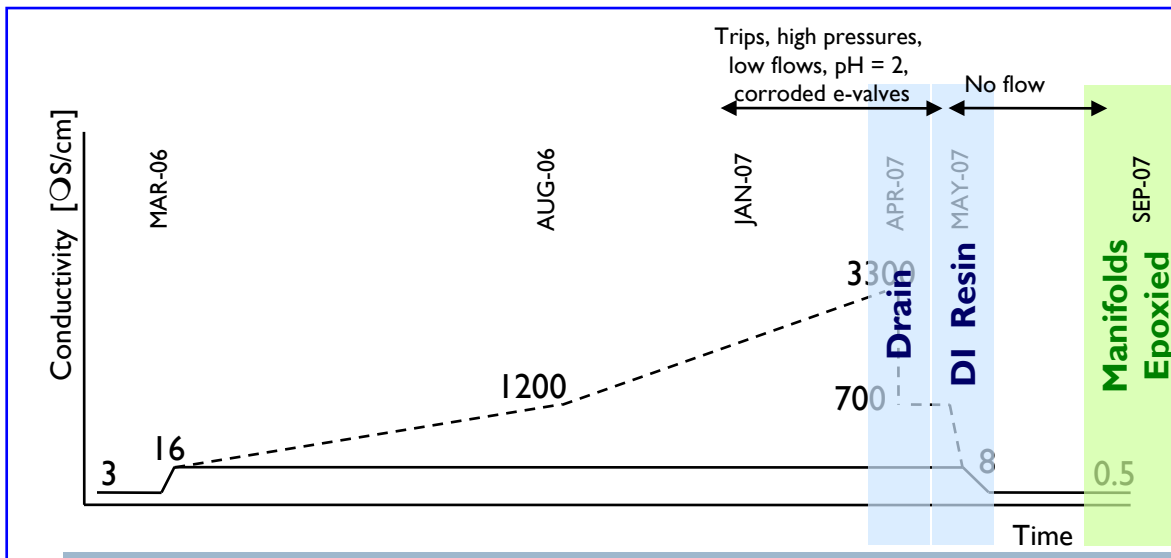
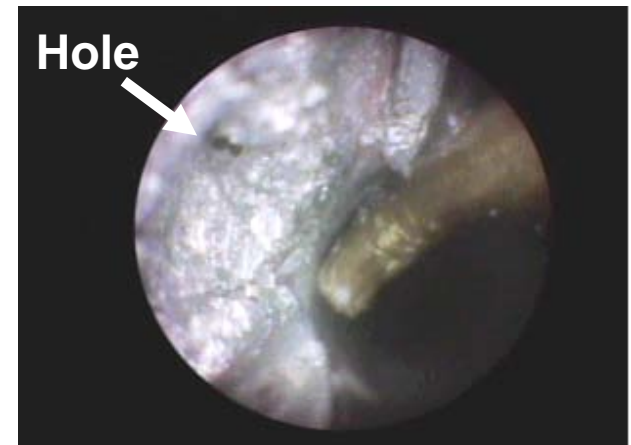
# ISL Cooling System: The Saga of 2007

- ◆ Internal walls of pipes were probed using boroscopes and catheters (~1 m inside CDF detector)
  - Port Card manifold-pipe junctions **were coated with epoxy**
  - Brass e-valves were replaced (mounted on CDF detector)
- ◆ The ISL coolant was replaced with deionized water
  - Expanded monitoring of **pH and conductivity**
  - Frequent replacement of deionizer (DI) resin filters

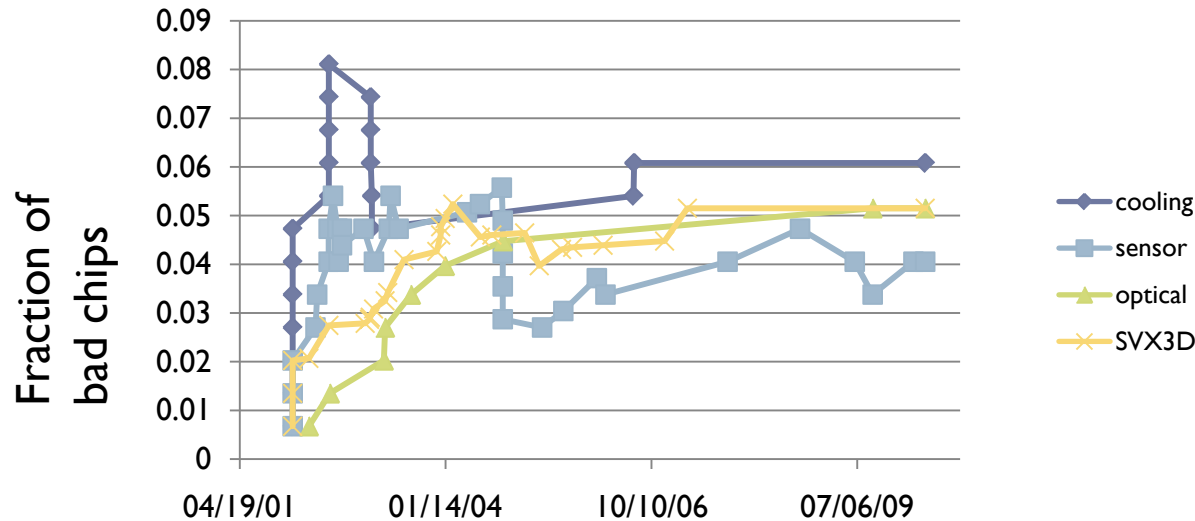
# Chip accounting - ISL

- ▶ No jumper failures for ISL because readout happens only after L2 accept
- ▶ No AVDD2 failures because of warmer temperature than SVX
- ▶ Sensor recovery after JC pushes (disconnected cables)
- ▶ Long history of cooling problems
  - ▶ 2003 – unblocked cooling lines
  - ▶ 2007 – major leak repaired

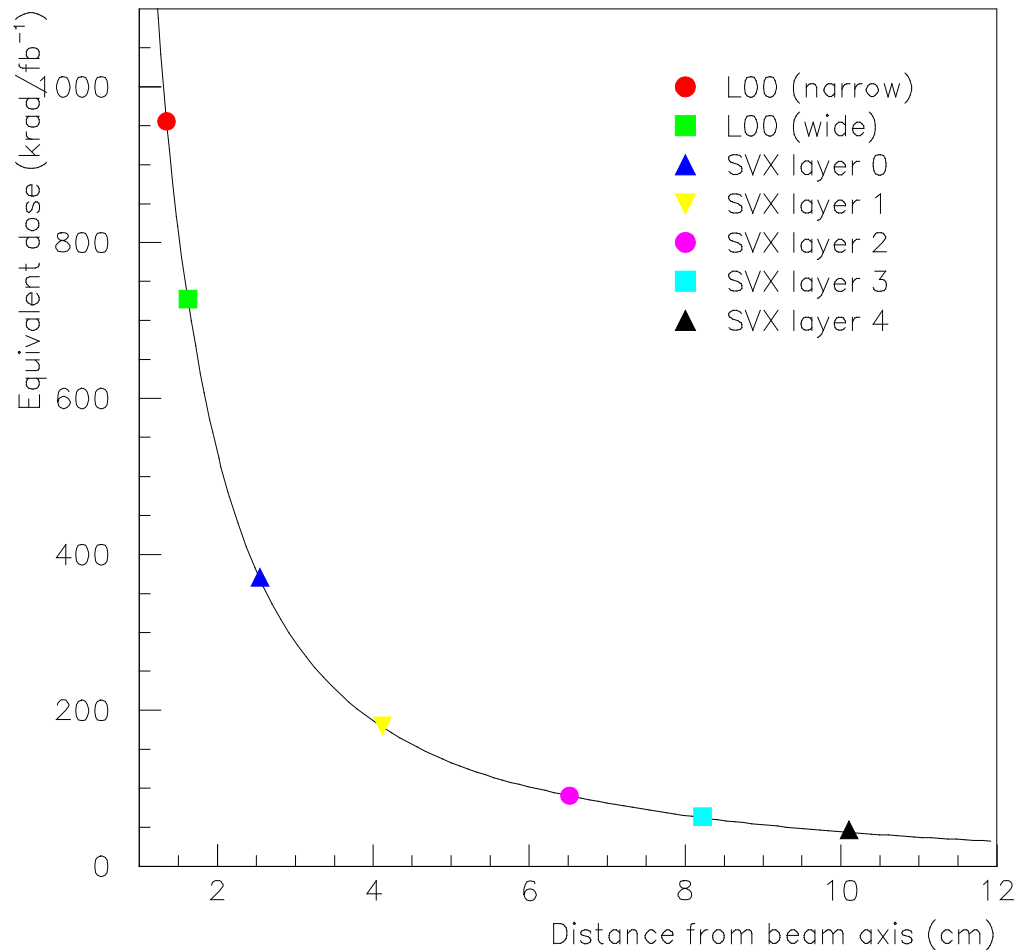
# Measured Radiation Field

- Radiation field measured with TLDs outside the silicon volume in 2002-2003.
- NIMA514 188 (2003)
- Bias current evolution 2002-2004 consistent with this radiation dose
