# **MERIT Progress Report**

Collaboration Phone Meeting

September 21, 2007

# The MERIT (nTOF11) Experiment

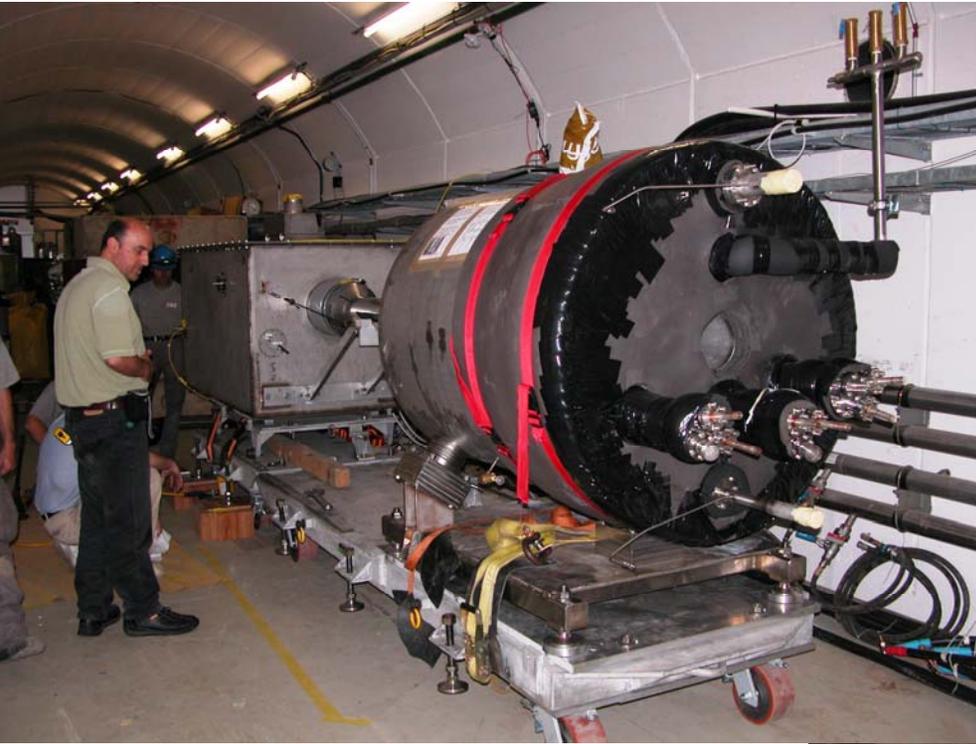
**Before Mating**

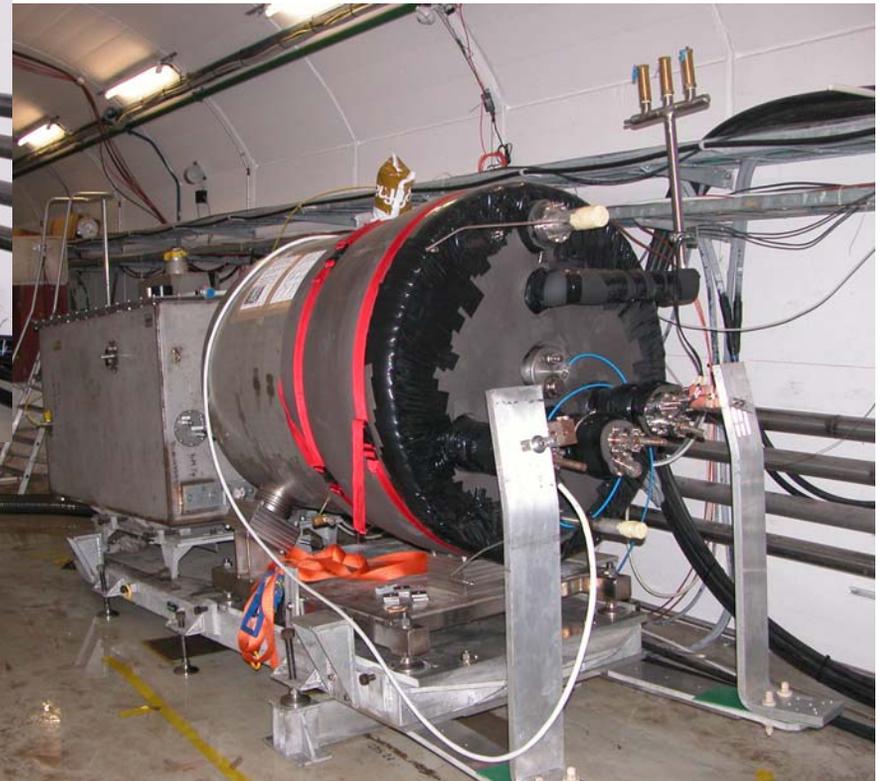
**After Mating and Tilting**

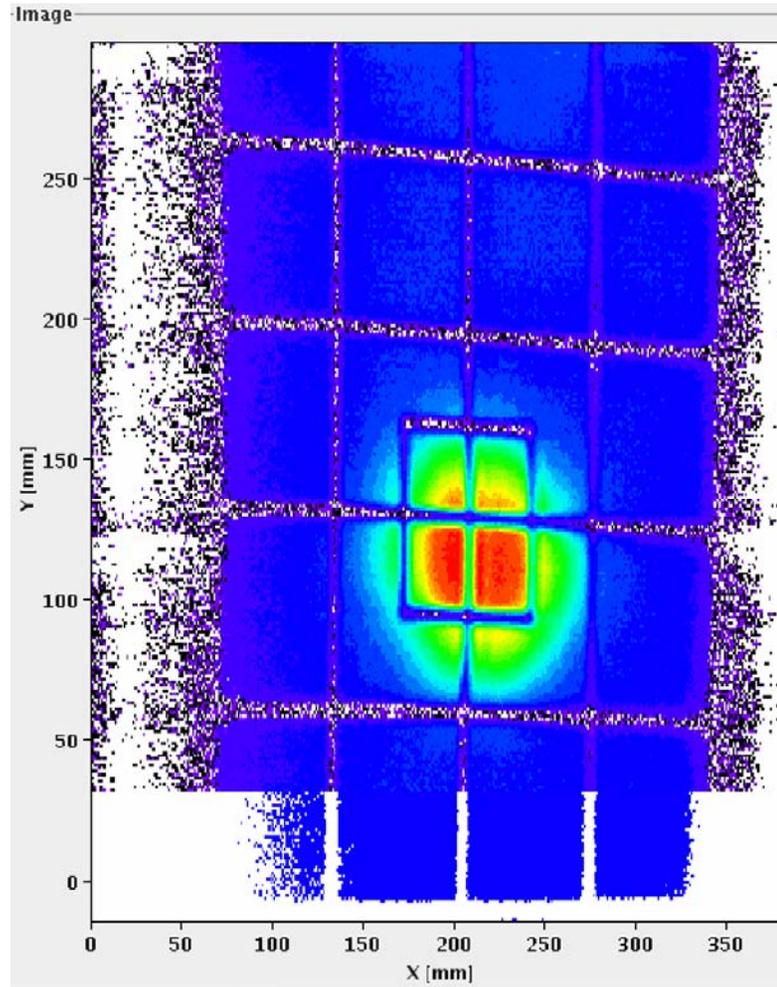
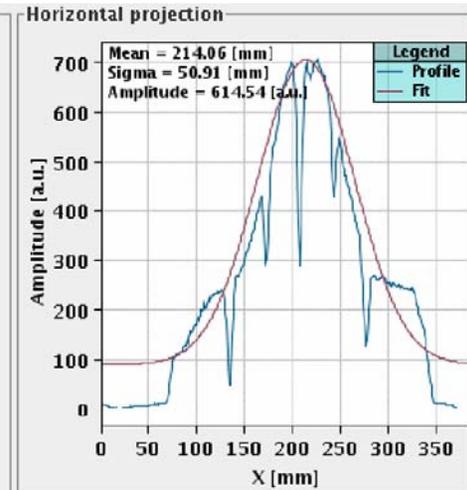
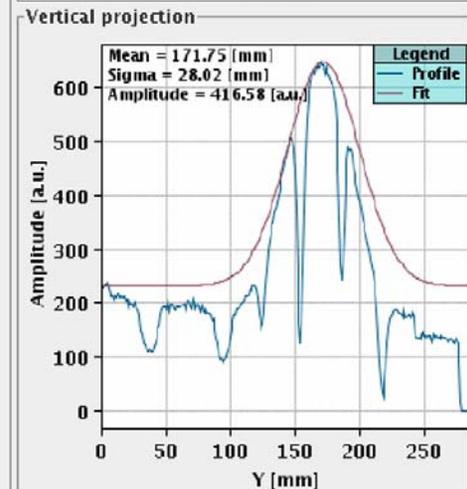
# First Beam August 24

14 GeV  
 $2 \cdot 10^{11}$  ppp  
 $\sigma_x$  (rms) 7mm  
 $\sigma_y$  (rms) 4mm

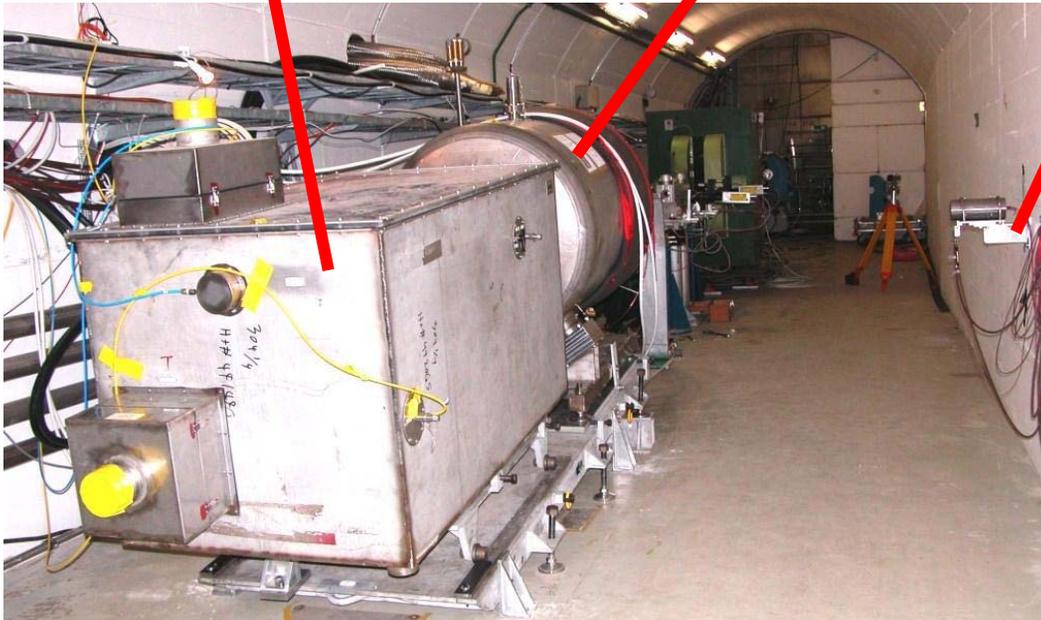
Secondary Container  
For Hg Injector

15T Pulsed Solenoid

Al Cathode and  
Diamond Detectors

View of experiment looking upstream in TT2a

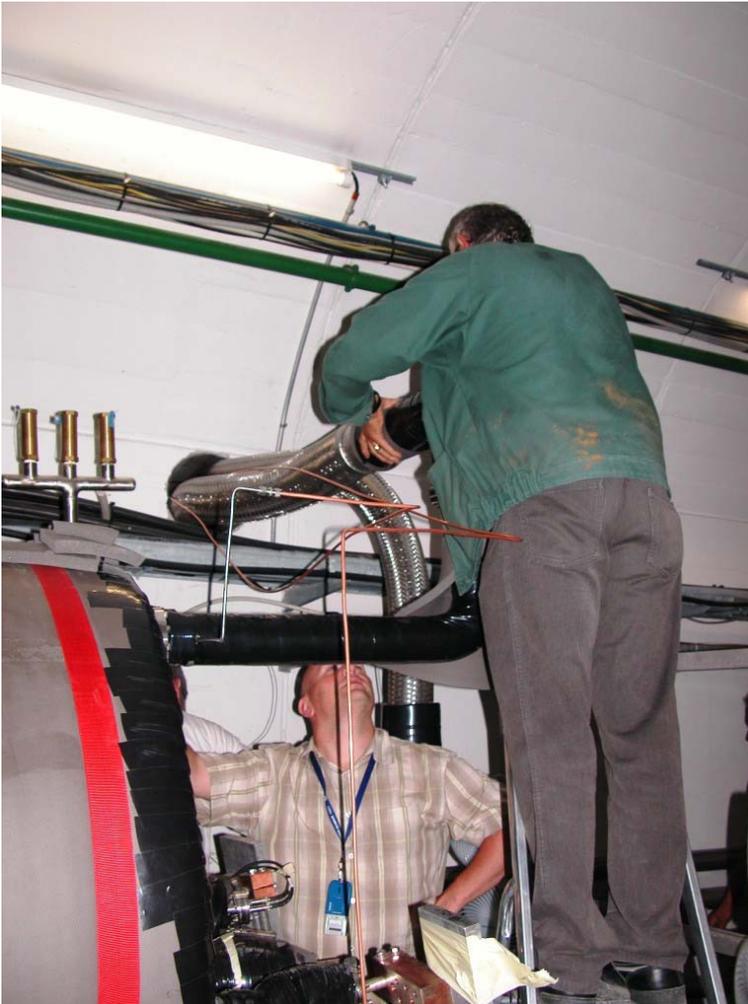
Transfer Lines to the Solenoid

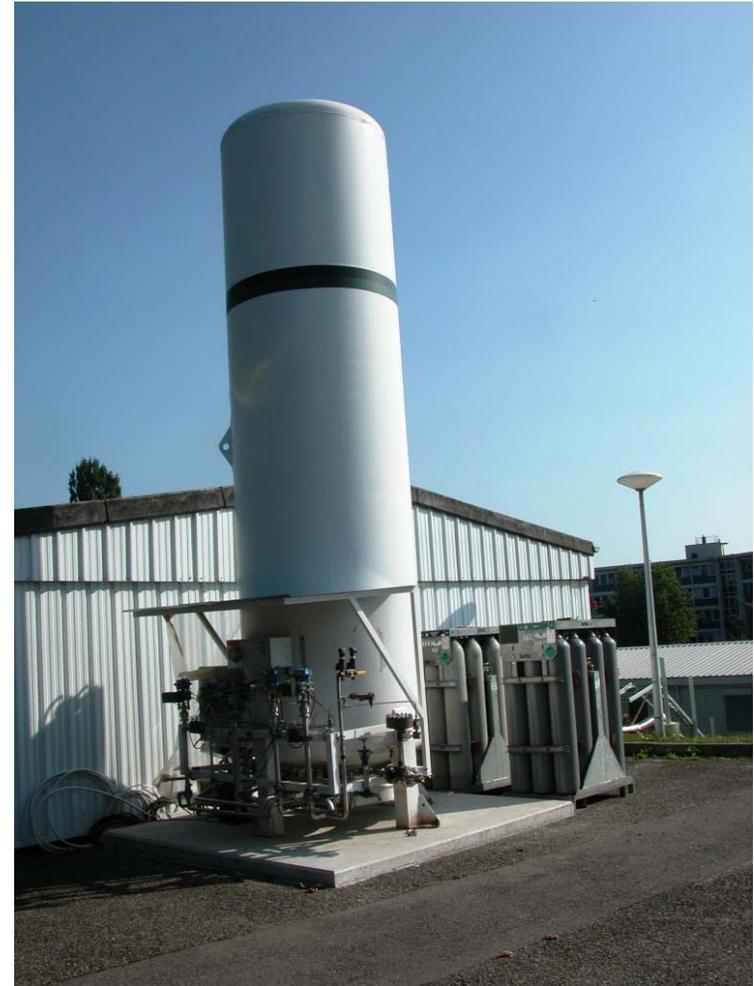
Surface Cryo Components

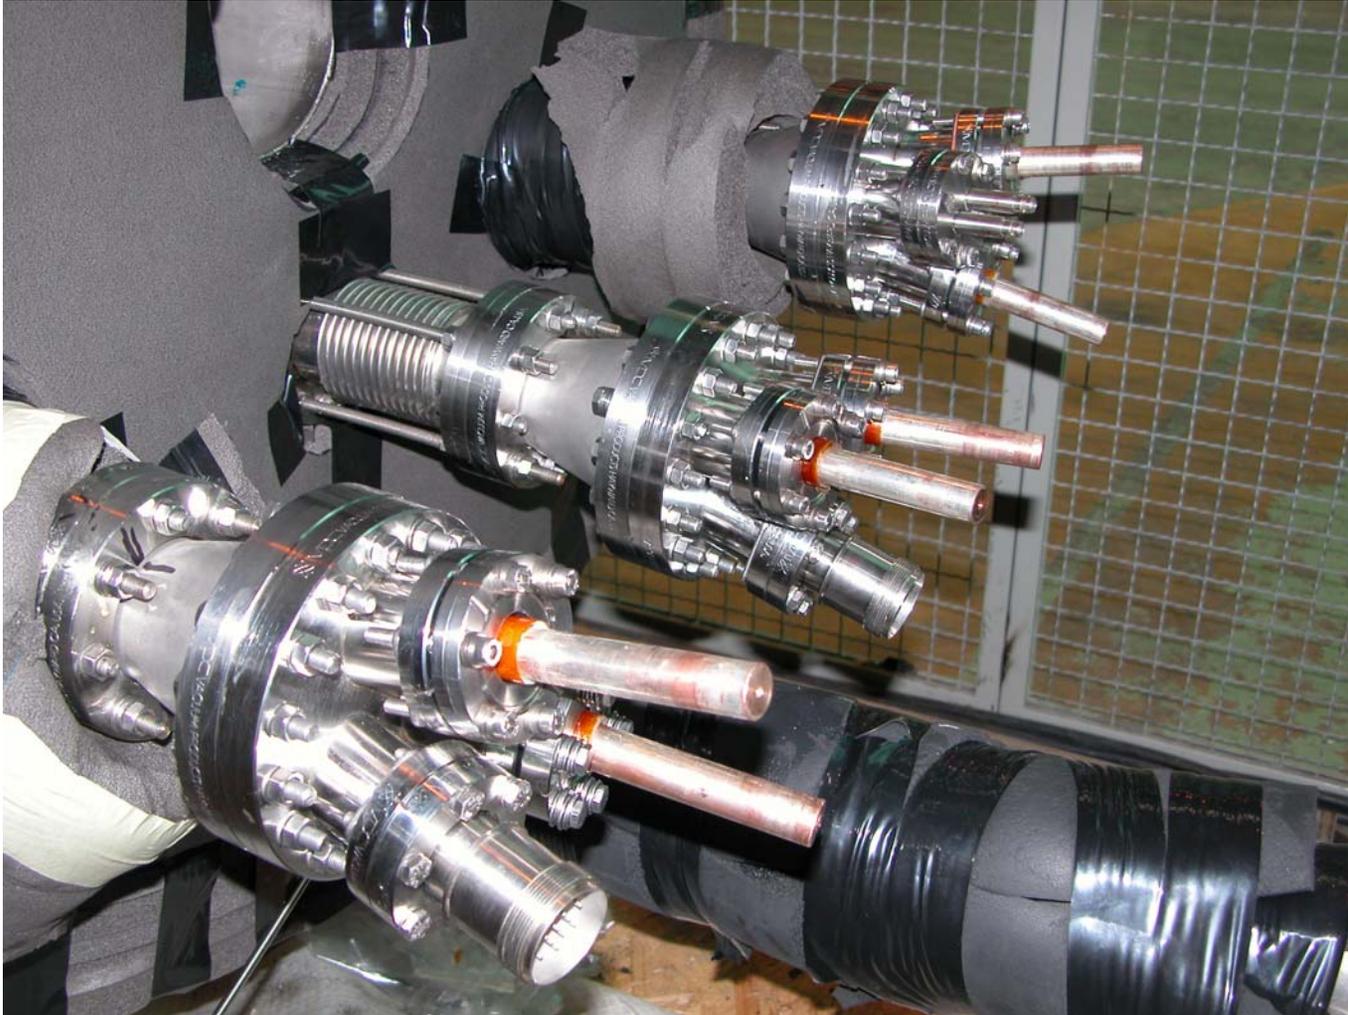
# The Coil Leads

Hipot Test

Outer  $8G\Omega$

Middle  $90G\Omega$

Inner  $50G\Omega$

May 31, 2007

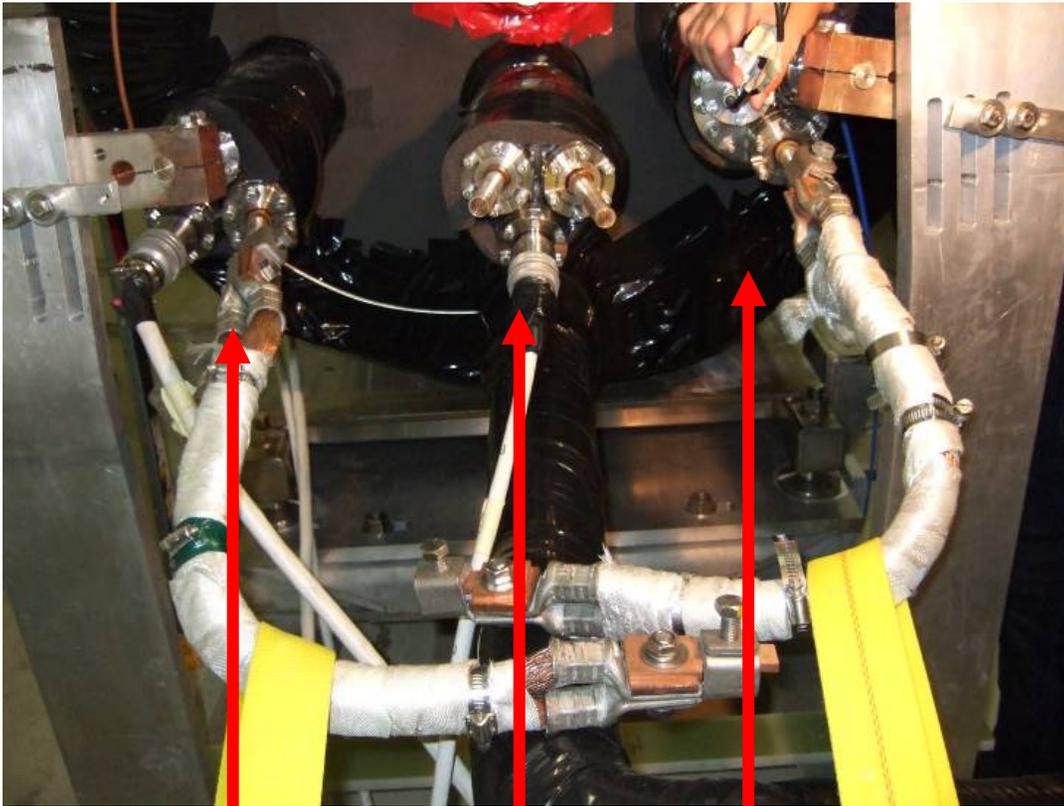
# HiPot Test Sept. 19

**Outer**

**Inner**

**Middle**

- Outer Coil  
**500 M $\Omega$**
- Inner Coil  
**600 M $\Omega$**
- Middle Coil  
**0.5 M $\Omega$**

# Excess Heating of the Solenoid

- Problem discovered- PS turned off
- Solenoid temperature peaks at 175<sup>0</sup> C

Solenoid is being actively cooled to RT. Further diagnostics will be done.

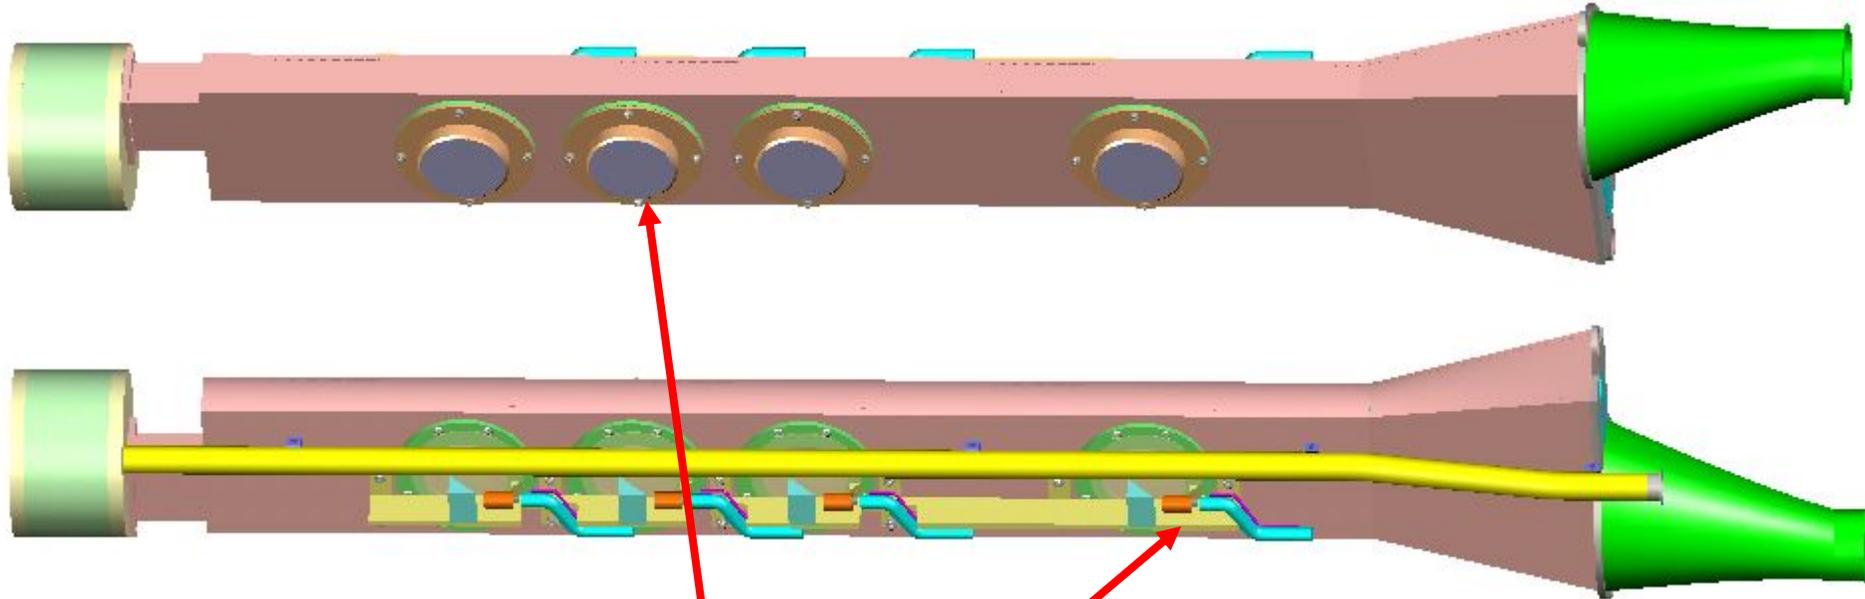
Reflectors

Illumination,  
Lens and  
Imaging

One set of optics per viewport

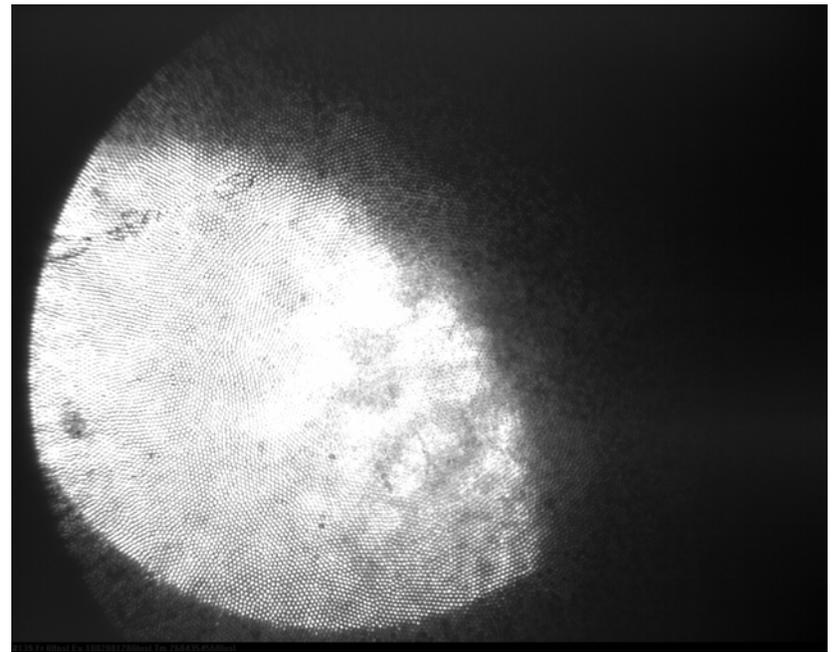
**Viewport 1, Sep. 19, 2007**

Temperature (°C) on HPU display  
Primary : 77  
Secondary : 30

A TT2a access is requested to permit re-alignment of the primary optics.

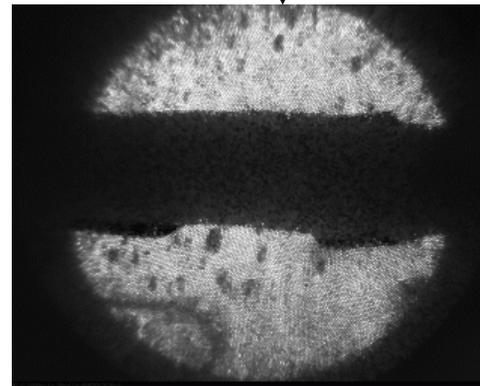
0.1 ms/frame

20 m/s Hg jet, 7 Tesla field

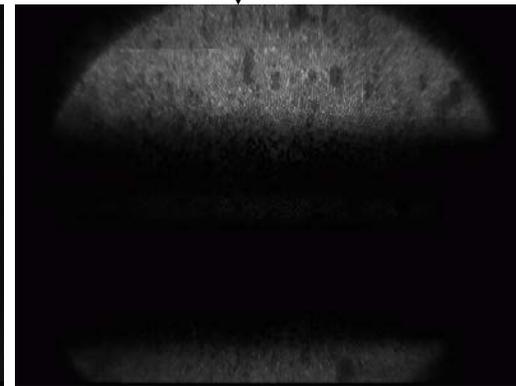
2 ms/frame
